## Commercial Vehicle Enforcement

### NORTHEAST SECTOR:

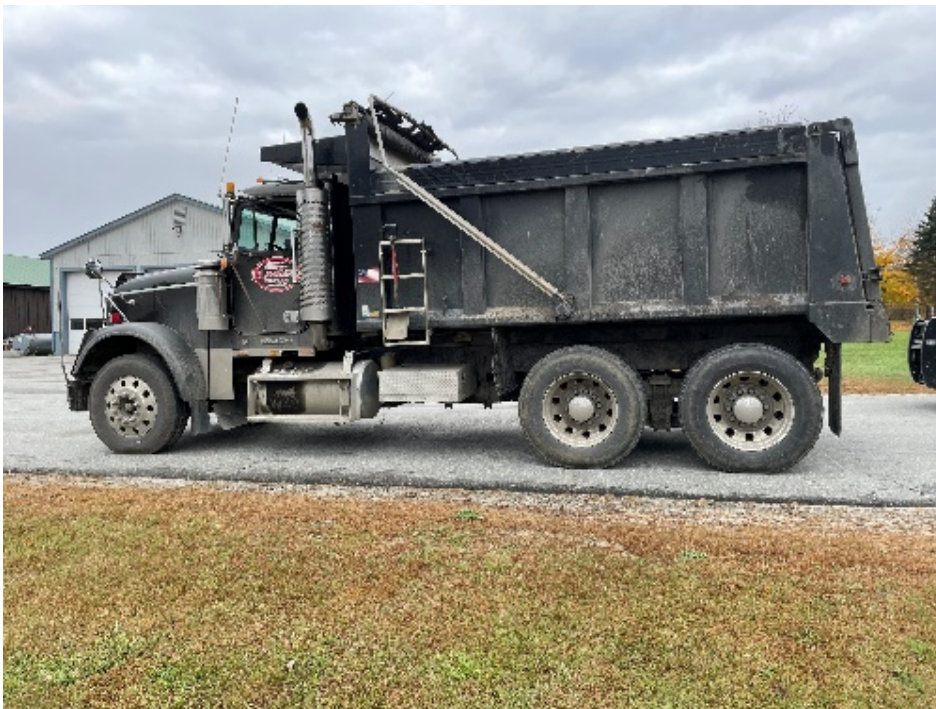
- 10/18 Island Pond, VT Rte 114. Inspectors conducted a portable weigh on a CMV. The CMV was found to be 6,800 pounds over permitted weight. A ticket was issued to the company.

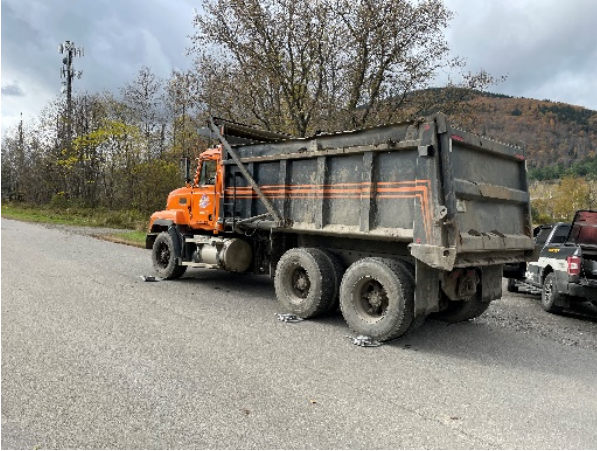
- 10/18 Lemington, VT Rte 102. Inspectors conducted a portable weigh on a CMV. The CMV was found to be 11,000 lbs over weight with no permit. The CMV was grounded until the carrier obtained a permit and a ticket was issued to the company.

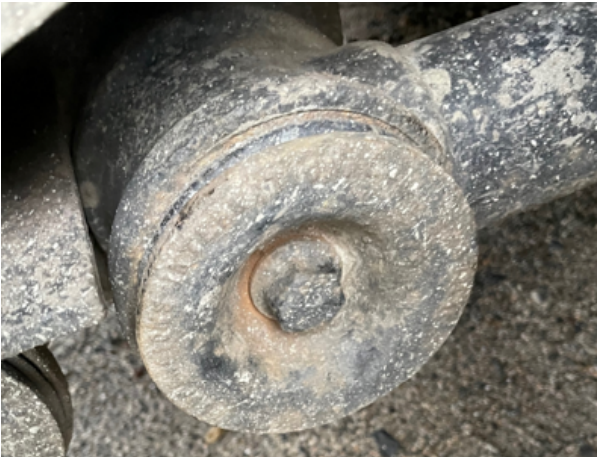
- 10/16 Concord. An Inspector discovered a loose suspension tracking component during an inspection. The loose bolt is evident by the dry, powdery rust surrounding the bolt head.

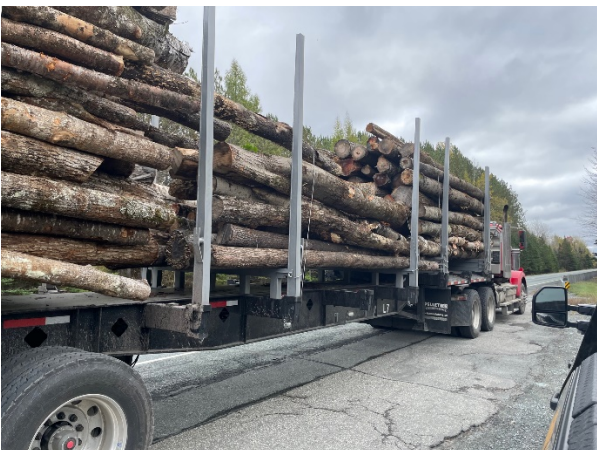
- 10/16 Concord. A CMV transporting logs was placed out of service for improper load securement- additional means of securement required.

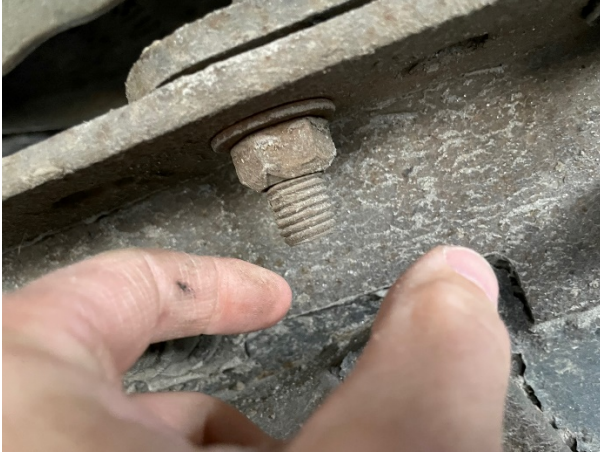
- 10/18 Woodstock, US Rte . An inspector discovered a loose bolt securing the lower fifth wheel halve to the frame. The violation did not meet the out of service criteria.

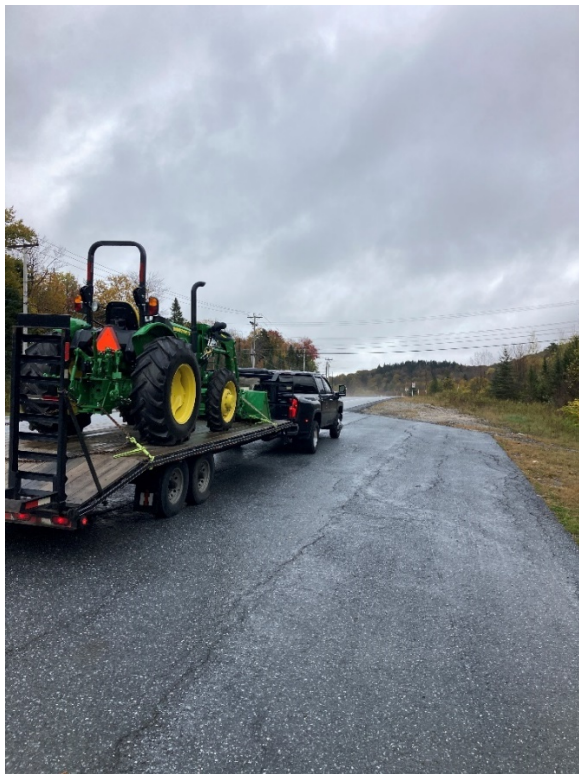
- 10/16, Inspector stopped a truck towing a tractor on Route 4 in Mendon. The operator had no log when he was required to have an ELD. The driver was placed out of service for 10 hours at the Killington Deli.

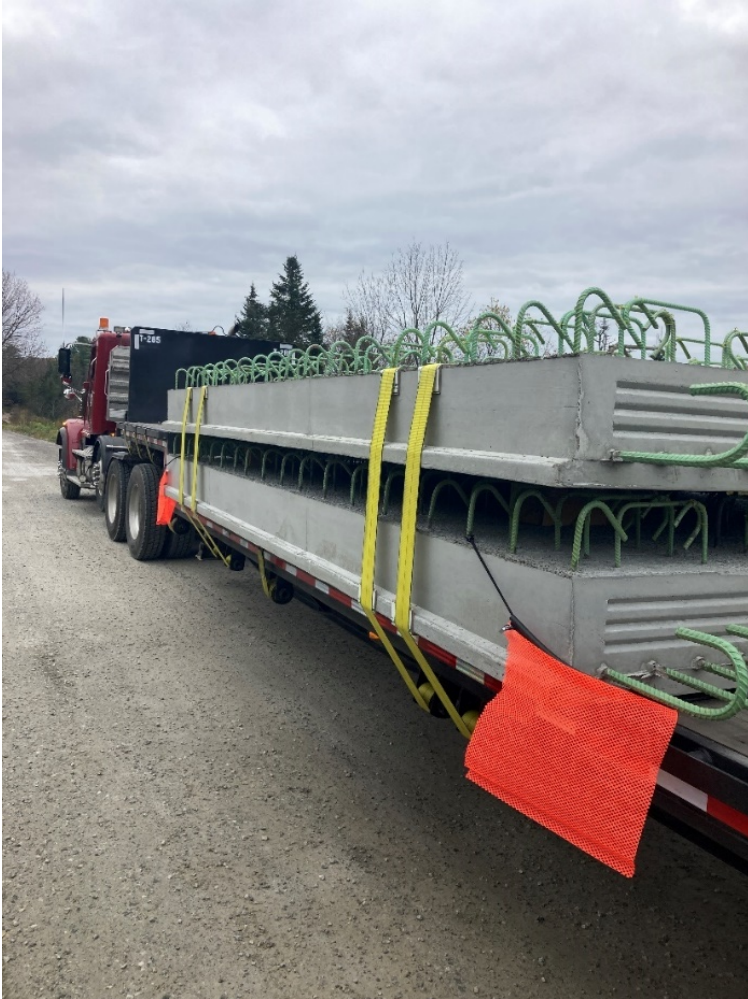
- 10/17, Inspector placed a tractor trailer out of service for inadequate cargo securement on Route 103 in Mt. Holly. The concrete precast blocks weighed approximately 52,000 pounds and the driver only had 16,000 pounds of downward force. The driver added more straps and was allowed to continue.

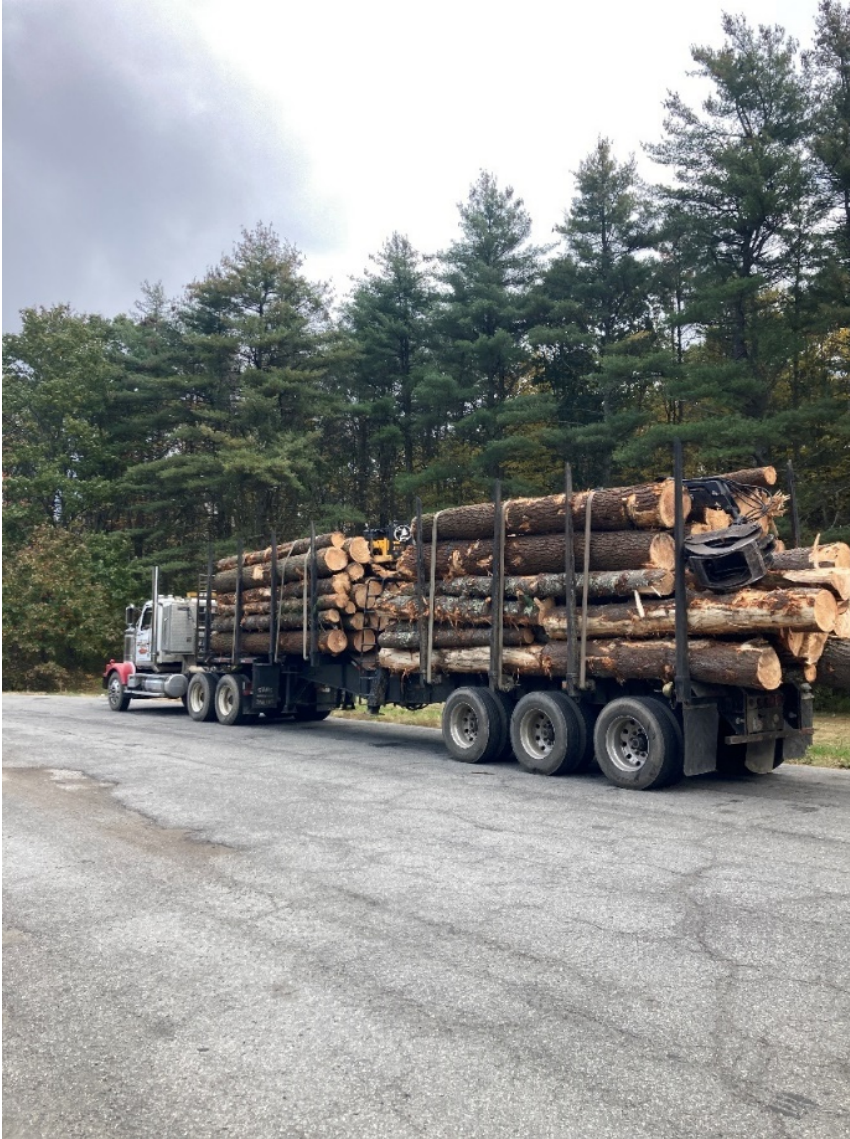
- 10/19, at the Springfield NB Detail, Inspector weighed a 6-axle log truck. The truck had no overweight permit and had an actual weight of 112,200. The carrier was force permitted and a VCVC was issued.

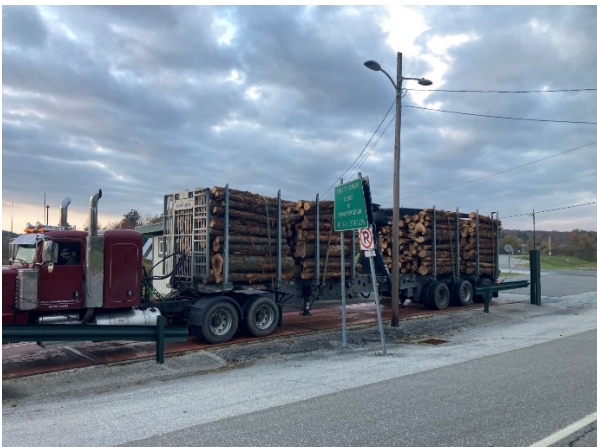
- 10/20, Inspector stopped a 6-axle log truck in Castleton and escorted them to the Scale house for a weigh. The truck weighed 110,200 on a 99k permit. A VCVC was issued to the carrier.

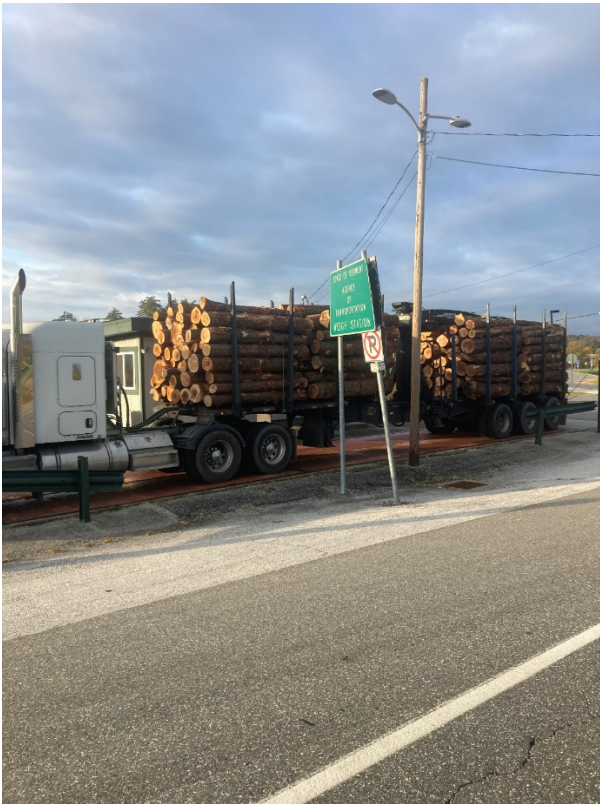
- 10/20, Inspector stopped a 6-axle log truck in Castleton and escorted them to the Scale House for a weigh. The truck weighed 114,000 on a 99 K permit. A VCVC was issued to the carrier.

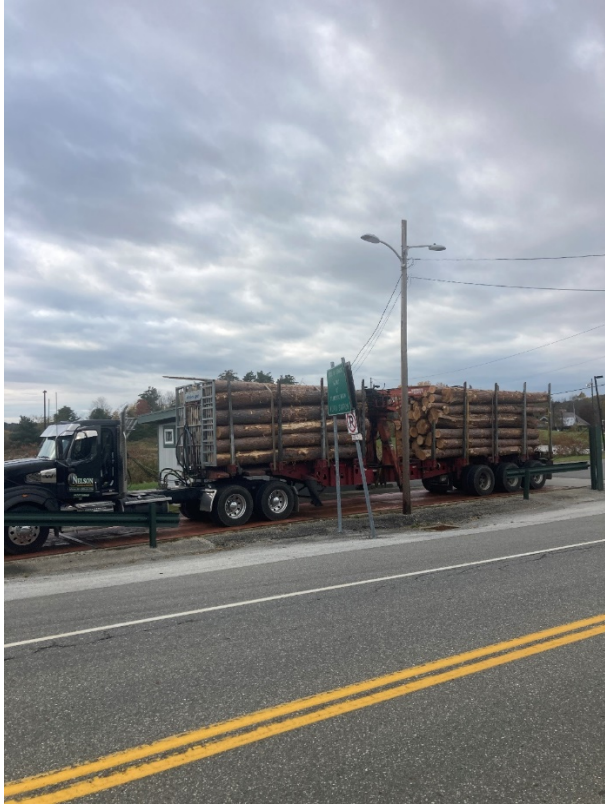
- 10/20, Inspector stopped a 6-axle log truck in Fair Haven and escorted them to the Scale House for a weigh. The truck weighed 117,640 on a 99 K Permit. A VCVC was issued to the carrier.

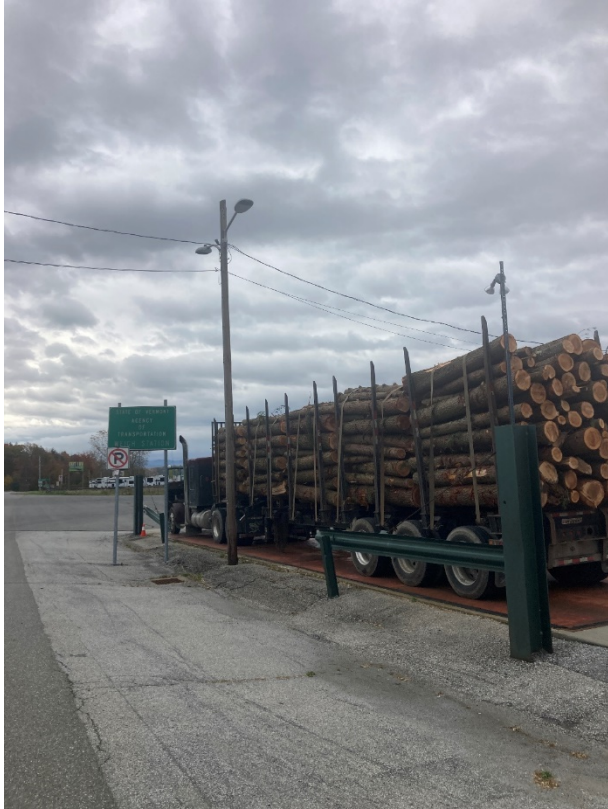
- 10/20, Inspector stopped a 6-axle log ruck in Fair Haven and escorted them to the Scale House for a weigh. The truck weighed 117,460 on a 99k Permit. A VCVC was issued to the carrier.

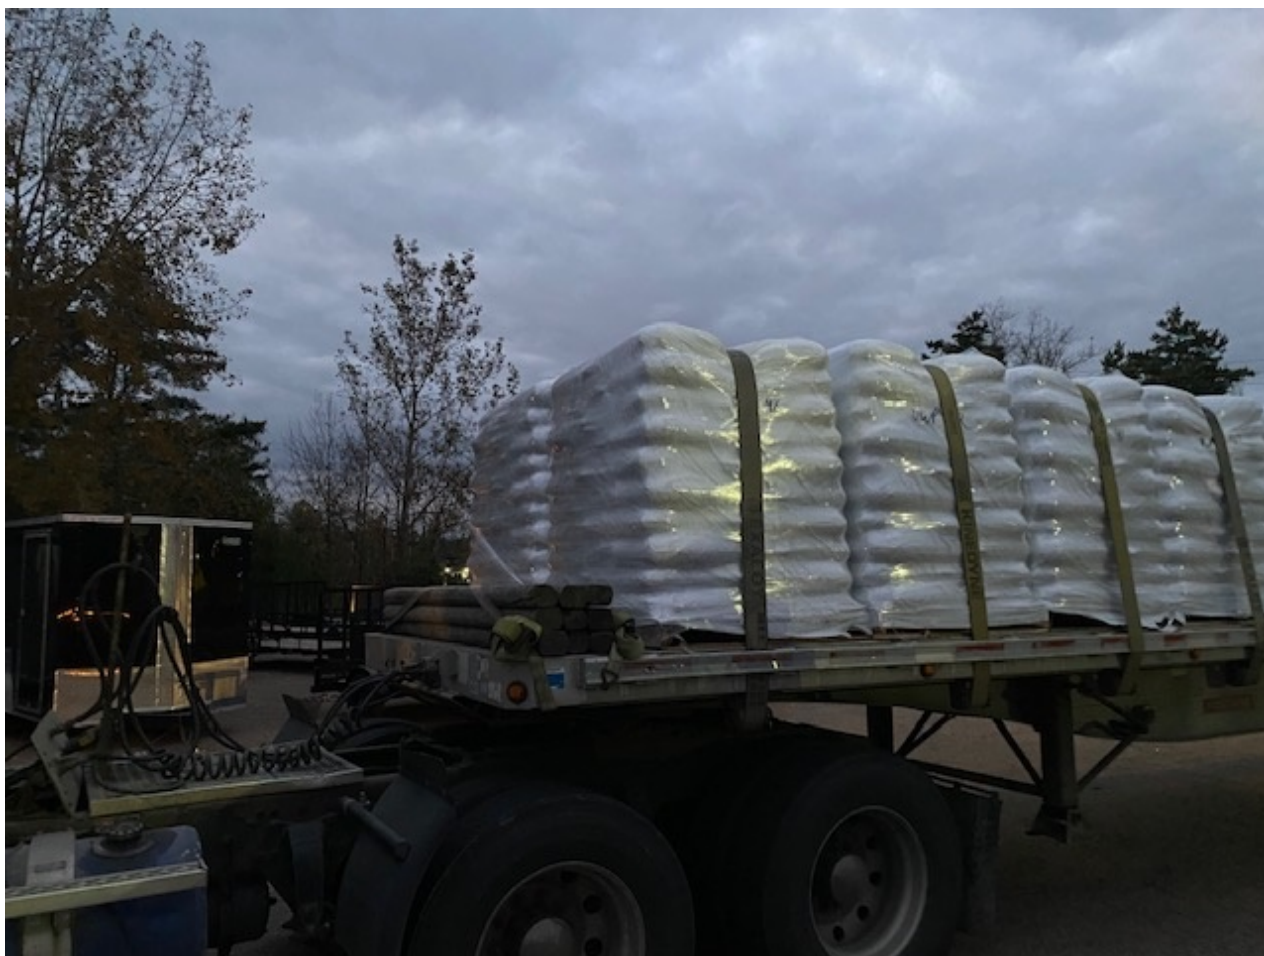
- 10/17 Cpl. inspected a box truck at the Georgia detail. The inspection revealed the truck's steering suspension was defective and the drag link had significant movement under hand pressure. The truck was placed out of service for the defect.
- 10/17 Cpl. inspected an interstate tractor trailer at the Georgia detail. The carrier was found to be under suspension in Vermont. The vehicle was grounded until the carrier was reinstated.
- 10/19 Cpl. stopped a tractor trailer operating on I 89 through Colchester for a load securement violation. An inspection was conducted, and the trailer was placed out of service for securing two pallets of wood pellets with only 1 strap and the load was not blocked/braced against forward movement. The driver remedied the out of service defect by adding an additional strap.

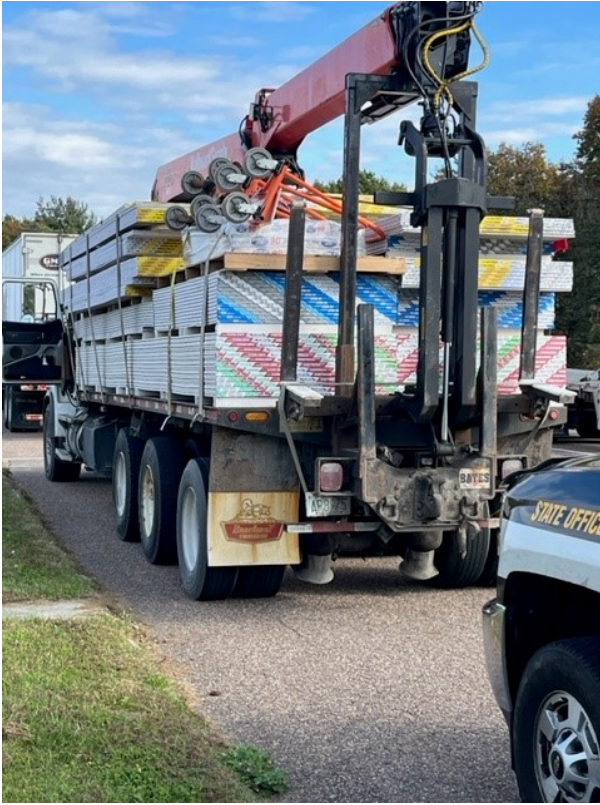
- 10/19 Insp. conducted a portable weigh at the Colchester detail of a flatbed truck. The vehicle was found to be 10,500 lbs overweight. A ticket was issued for being over its registered weight. The carrier contacted CVO and a forced registration was conducted.

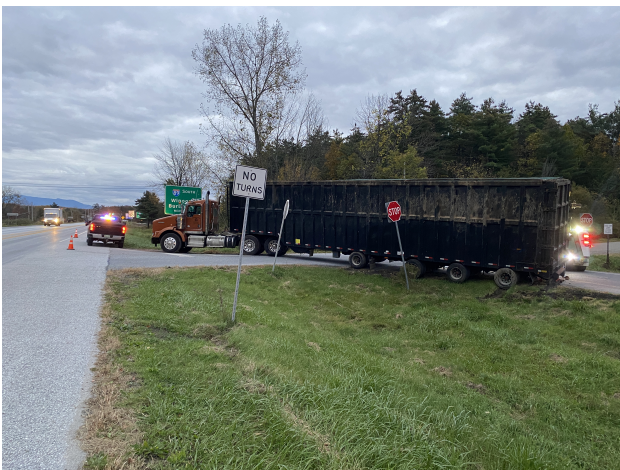
- 10/19 Cpl. inspected a tractor trailer unit at the Colchester detail. The trailer was placed out of service for a severely deflated tire.
- 10/19 Lt. was alerted by VTrans, through VSP that a tractor trailer had become stuck on US Rte. 2 in Colchester near Niquette Bay Rd. It was reported that the truck was being removed by a heavy wrecker service. It was discovered that the driver had taken the wrong ramp, instead taking the Niquette Bay Rd off ramp, instead of the Interstate 89 South onramp. No other improper driving was discovered and the vehicle was removed.

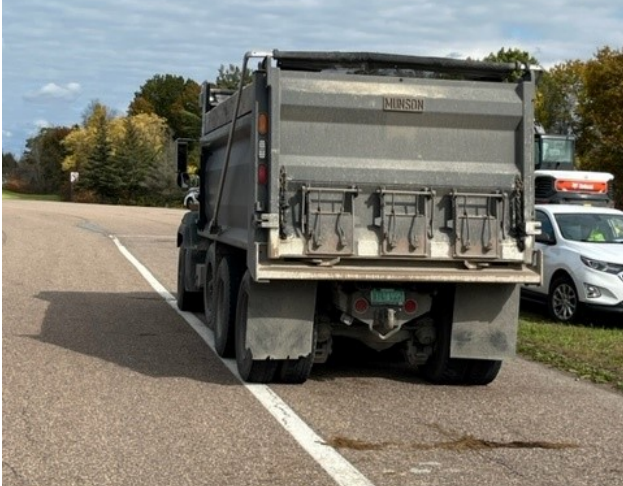
- 10/19 Insp. conducted a portable weigh of a dump truck at the Colchester detail. The vehicle was found to be 19,100 lbs overweight. A ticket was issued for over road limits and the carrier contacted CVO and a forced permit was conducted.

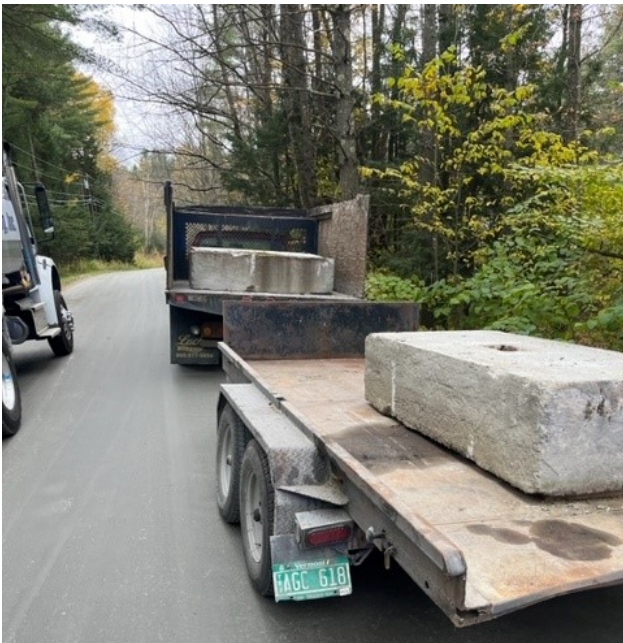
- 10/20 Insp. stopped a truck/trailer combination in Berlin. A portable weigh was conducted and the truck was found to be 11,400 lbs overweight. A ticket was issued for being over its registered weight. The driver was issued a warning for load securement.

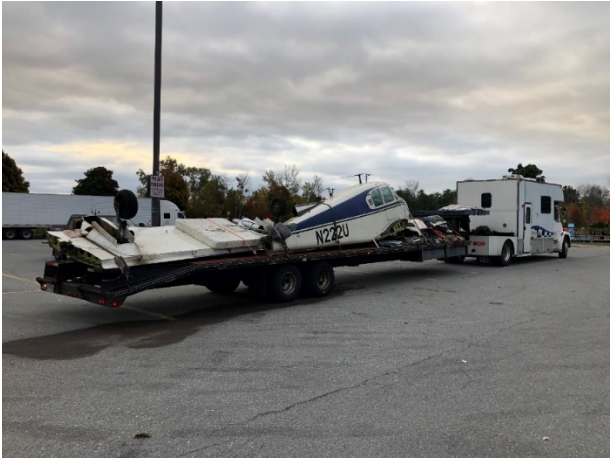
- 10/20 Cpl. stopped an interstate truck and trailer for an inoperable lamp in Williston. An inspection was conducted, and the trailer was placed out of service for a load securement issue and the driver was cited for a false log.
