## Commercial Vehicle Enforcement

### NORTHEAST SECTOR:

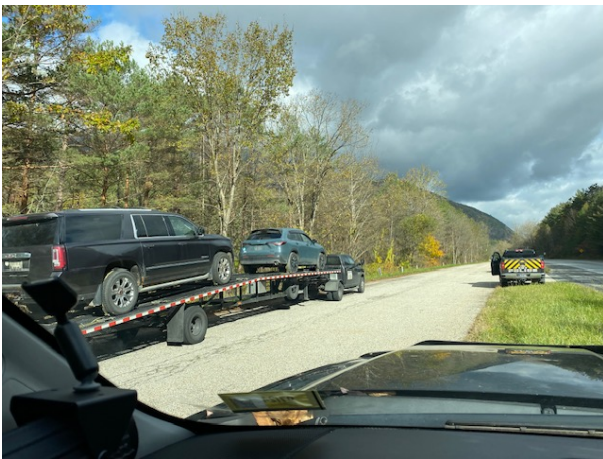
- 10/17, Emerald Lake Detail. 47 CMV's were screened. 4 level 1, 4 level 2 and 3 level 3 inspections were conducted. 1 portable scale weigh and 6 permits were checked with 1 overweight violation with a \$116 VCVC issued. 1 vehicle violations and 5 driver violations were discovered.

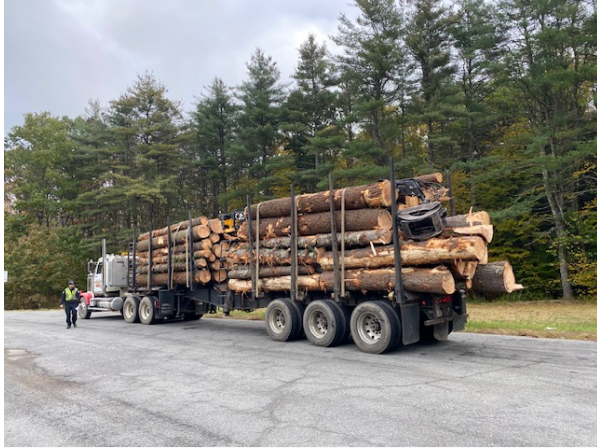
- 10/19, Springfield NB Rest Area. 123 CMV's were screened. 6 level 1, 2 level 2 and 2 level 3 inspections were conducted. 1 portable scale weight and 6 platform scales were conducted, 6 permits were checked with 1 overweight violations, 1 VCVC's were issued totaling \$1437. 2 driver violations and 4 vehicle violations were discovered. 2 vehicles were placed out of service.
